Lead externalization – a potential source of lead-related infective endocarditis?

Maciej Polewczyk¹, Dorota Nowosielecka², Konrad Tomków³, Łukasz Tułcecki³, Andrzej Kutarski⁴, Anna Polewczyk¹

Adv Interv Cardiol 2018; 14, 3 (53): 316–317
DOI: <https://doi.org/10.5114/aic.2018.78340>

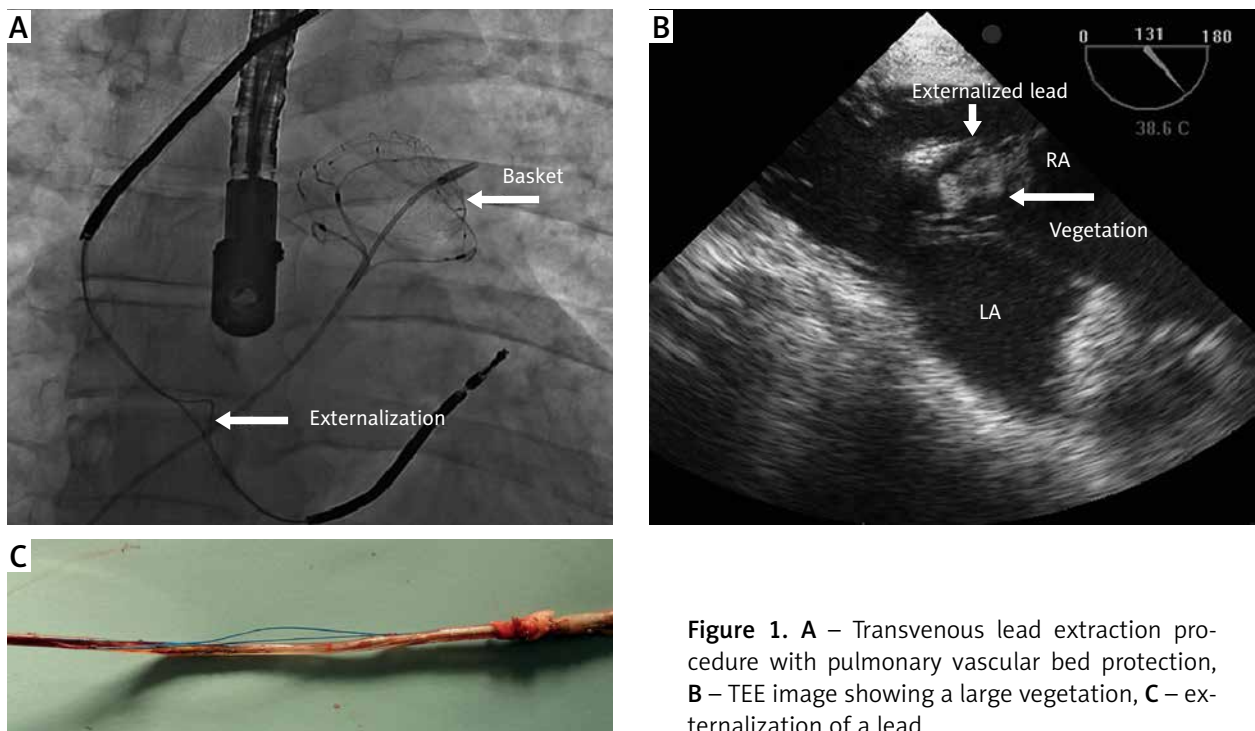
ical, USA) defibrillating lead showed significant cable externalization with remnants of the vegetation and relevant lead degeneration (Figure 1).

Lead externalization is relatively common among Riata leads. However, in the literature we may find cases of such a phenomenon in different leads produced by different manufacturers [1]. The mechanism of externalization of Riata leads is related to their specific construction. Inside there are several conductors which may move relative to the insulation, leading to its further damage – ‘inside-out abrasion’. In some research there was no evident correlation between lead externalization and electrical failure [2], but a large Canadian registry confirmed the impact of externalization on lead failure [3]; in our case the electrical parameters of the ICD system remained stable. The influence of lead externalization on LRIE development has not been investigated yet; there are only a few similar reports [4]. An externalized cable might be thrombogenic. A thrombus formation around the location of externalization may become the origin of a further infection. According to the recent reports, some patients with vegetations even exceeding 4 cm in diameter underwent TLE, avoiding cardiac surgery. However, the decision of the extraction method was made individually considering the total vegetation volume, the degree of infiltration of heart structures and the real risk of severe pulmonary embolism [5]. In clinical practice the decision of removal of a functional lead with present externalization remains problematic. Apart from possible electrical failure one should have in mind the fact that exposed internal lead conductors might be the chief sites of serious infection.

Figure 1. A – Transvenous lead extraction procedure with pulmonary vascular bed protection, B – TEE image showing a large vegetation, C – externalization of a lead
